TECH NOTE

VICON TECHNICAL SERVICES GROUP

Subject: Lines in pix of KOL-LMSW
Product: KOL-LMSW 3.0
Number: 1400-0001-47-00
Date: 2/5/03

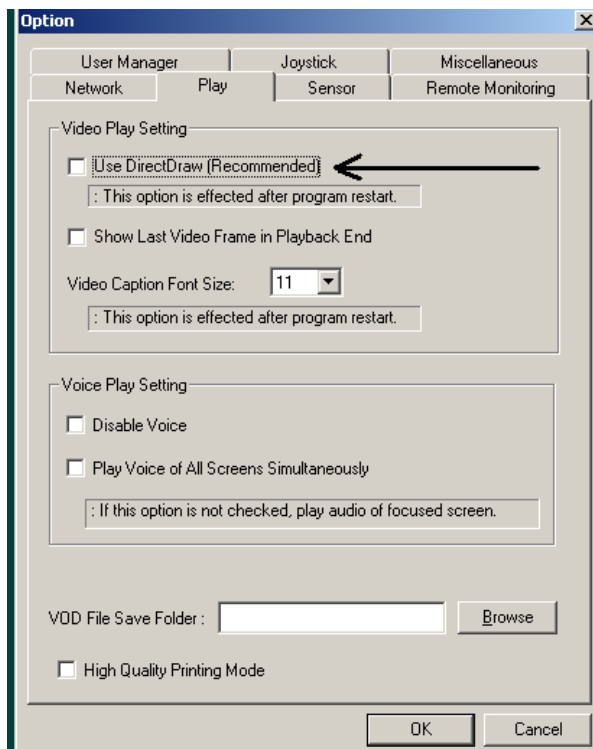
Lines or 'double images' in the Kollector picture display screens of LMSW.

- Go to setup (click ! On the main screen)
- Select the Play tab as below, uncheck "Use Direct Draw"
- Click OK, then exit and restart LAN master.
- Pictures from a connected Kollector should display normally (no lines)
